## University of California, Office of the President Water Action Plan, 2019

## Executive Summary

The University of California Office of the President (UCOP) Water Action Plan (WAP) was originally developed in 2017 to meet the University of California (UC) sustainable practices policy (the Policy) growth adjusted goals of 20% water use reduction by 2020 and 36% reduction by 2025. In addition, the plan was developed to meet the Policy requirement that all sites create and submit a WAP to the UC Office of the President by December of 2017. This document was updated in 2019.

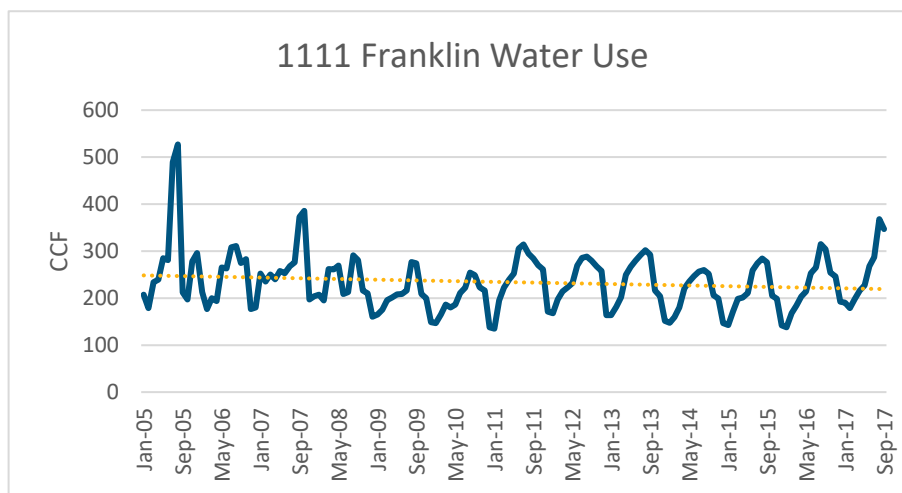
Graph 1: Time Series 1111 Franklin Water Use (Data Source - EBMUD bills)<sup>3</sup>

Graphs 1 and 2 plots water use based on utility bills from East Bay MUD, from 2005 to 2017. The graphs show a lower water usage during 2013-15 reflecting savings actions. However, despite no changes in occupancy of note, total water usage at 1111 Franklin has been increasing since 2015.

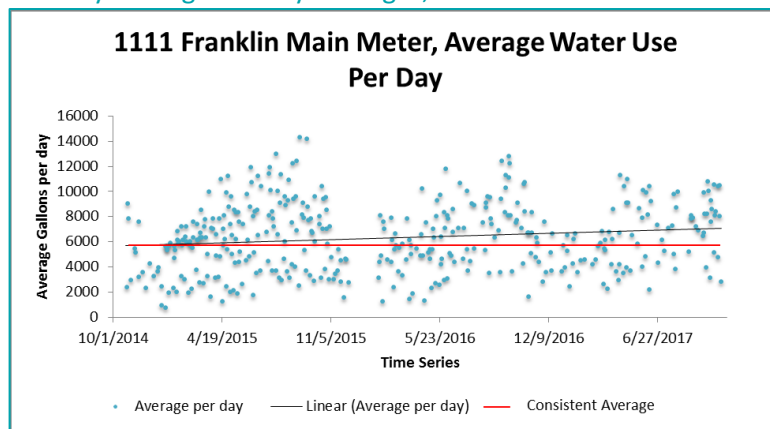
Graph 3: Monthly Average of Daily Averages, 1111 Franklin

The line of best fit (linear average per day, black) represents the progression of daily average over the time series when data was available. The red line represents a consistent daily average over the time period and is included for comparison purposes.

Data from this graph suggests an increase in daily averages of about 1400G/day. It is worth noting that this is a very rough method of estimation, but represents the best available method from the available data. This suggests the need for the installation of a data logger, to detect leakage (see recommendation 1 and appendix C).

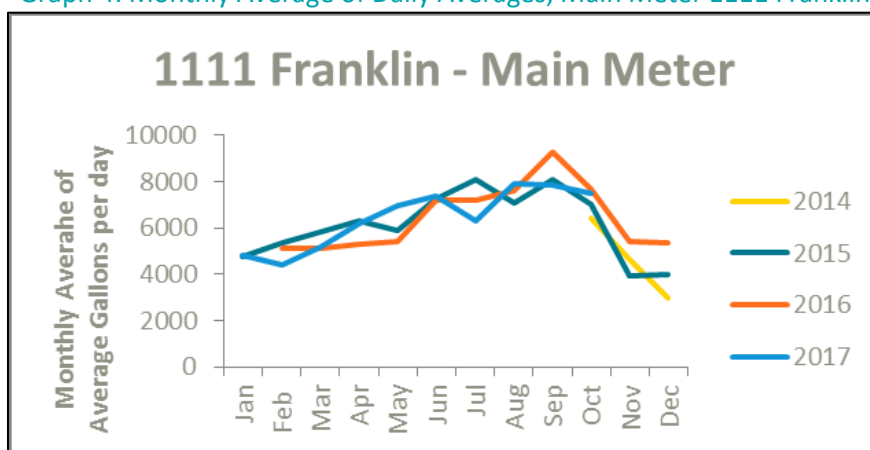
Graph 4: Monthly Average of Daily Averages, Main Meter 1111 Franklin

Graph 4 represents an average of daily averages within a given month.

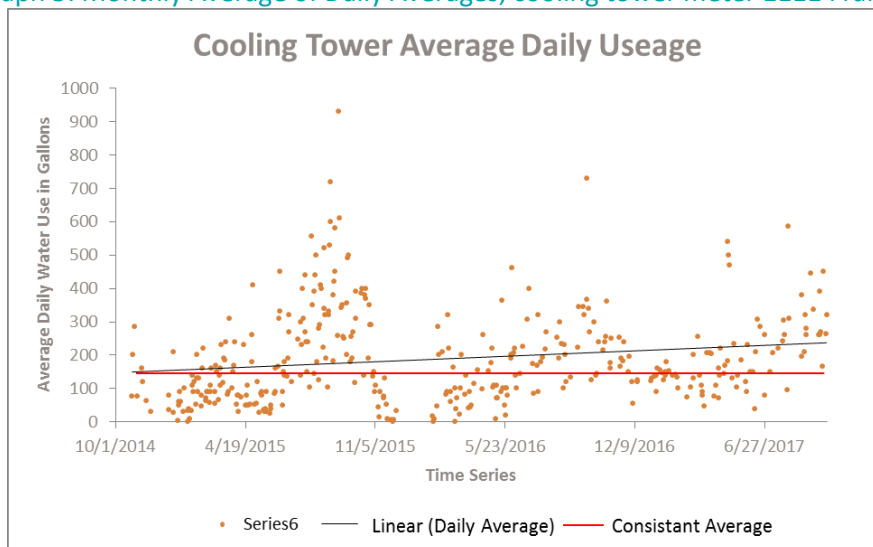
Graph 5: Monthly Average of Daily Averages, cooling tower meter 1111 Franklin

Graph 5 indicates peak use in summer months, with high usage in summer 2016.

Graph 5 demonstrates that daily averages in the cooling tower have tended to increase over-time, this increase is approximately 75 Gallons of water per day. The increased use in the cooling tower is significant, however, it does not account for all of the increase seen in the main meter.

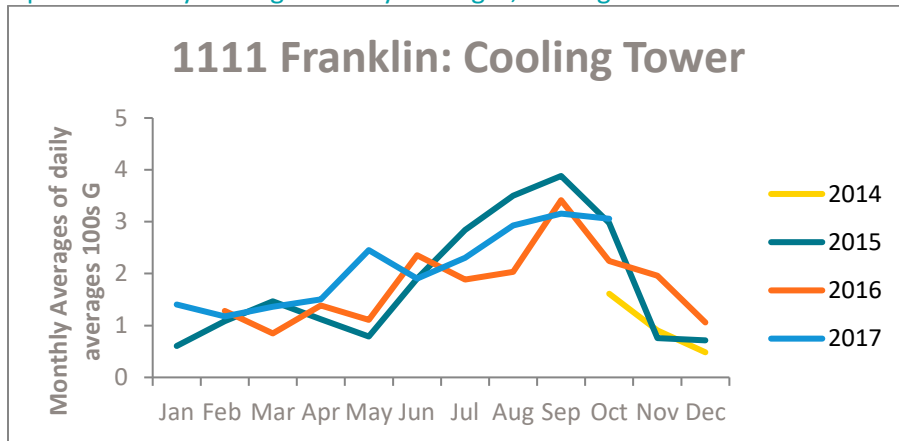
Graph 6: Monthly Average of Daily Averages, cooling tower meter 1111 Franklin

The monthly averages of data shown in the line graph (graph 6) indicate a more irregular water use in 2016 in the warmer months between June and October. This is suggestive of a more efficient system and reflects the improvements undertaken to the cooling tower during 2015 and 2016. When taken together with the cooling tower scatter graph (5), this suggests that increases to daily average in the cooling tower may be attributable to weather rather than system inefficiencies.

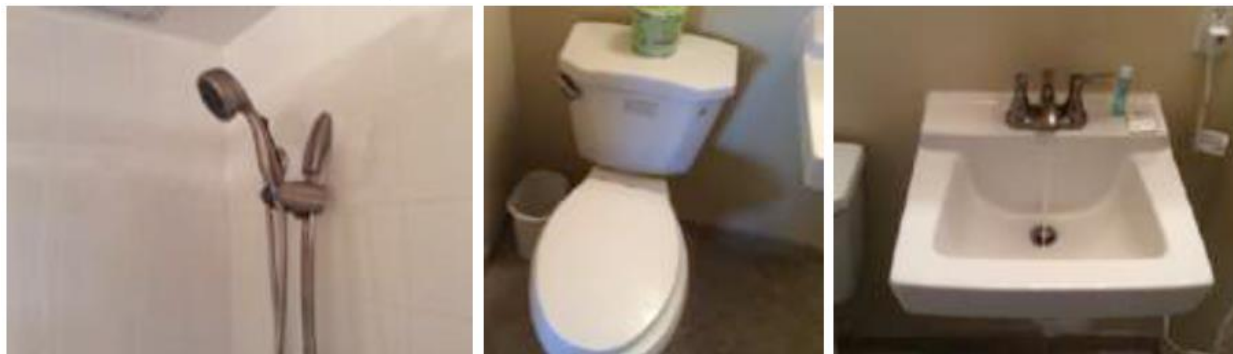
Figure 1: Typical UCDC Residential water fixtures (image figures 1 &amp; 2 sourced from Sustainable Building Partners LII Audit of UCDC [v1.1])

Fixture	Flow Rate	Notes
Toilet (public male)	1.60 gpf	
Toilet (public female)	1.60 gpf	
Toilet (residential male)	1.28 gpf	
Toilet (residential female)	1.28 gpf	
Urinal	1.00 gpf	
Public lavatory (restroom) faucet	1.50 gpm	UCDC plans to retrofit to meet WaterSense standards in 2018
Private (residential) lavatory faucet	1.50 gpm	Replaced between 2008 and 2015
Kitchen faucet	1.50 gpm	UCDC plans to retrofit to meet WaterSense standards in 2018
Showerhead	2.50 gpm	UCDC plans to retrofit to flow rate between 1.5 and 1.75 gpm in 2018
Cooling Towers	450 gpm	Maintenance done 2x a year

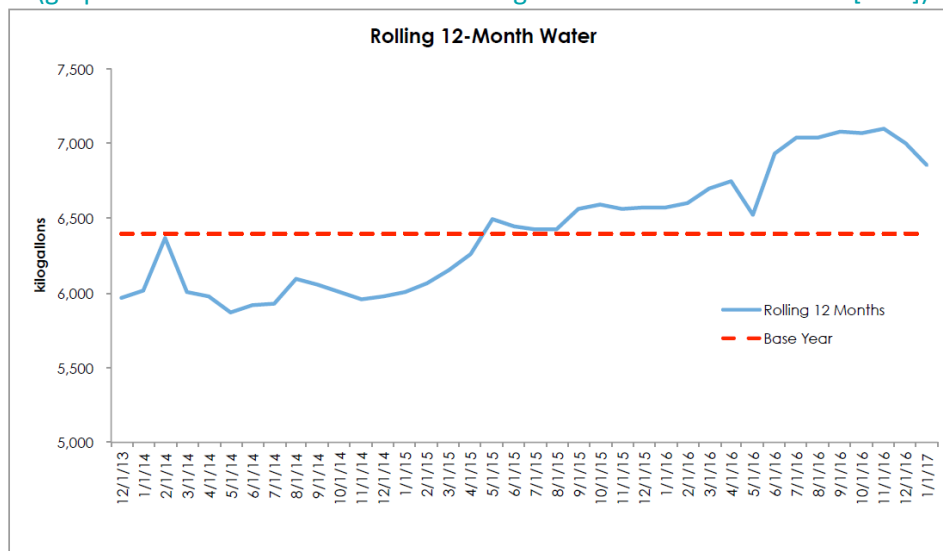
Graph 8: Rolling 12 Month Water Use  
(graph sourced from Sustainable Building Partners LII Audit of UCDC [v1.1])

It appears that water use has increased by 500- 1000 kilogallons (670-1135 CCF) over the time period analyzed.. Comparing water use numbers with the occupancy expressed in graph 8, there is significant water use increases in a period in which occupancy has not changed significantly. Some change can be explained by weather. From 2013 to the end of 2016, average summer temperatures in Washington D.C. have increased from 78.3 degrees to 80.5 degrees. The number of annual cooling degree days has also been on the rise. There were 1994 cooling degree days in 2016, which represents a marked increase from 2013's 1719 cooling degree days (xmACIS2, 2017).

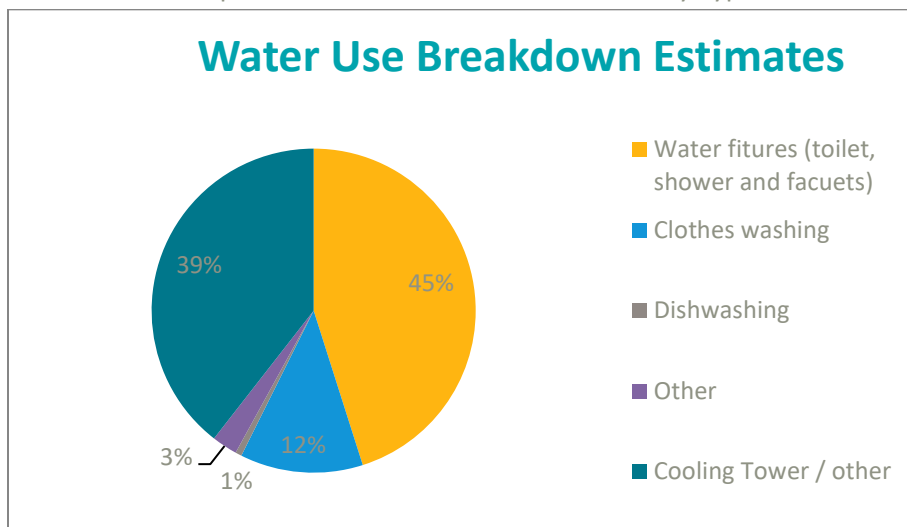
Graph 9: UCDC Water Use Broken Down by Type

Based on the calculations above (an estimate of ~3780 CFF from fixtures), using residential estimates from DeOreo et al (2015) and using an average of the last few years of total water use at UCDC (2015/16 : 9462 CCF and 206/17 - 7298 CCF), the portion of water use attributable to cooling towers, car park cleaning and other minor uses is about 33% of the total. This figure was obtained by subtracting estimated water in other categories from the average water use in 2015/16.

Typical residential water use benchmarks do not include facilities with central plants and cooling towers. Based on EPA's office benchmarks (EPA 2016), cooling and heating is typically about 36% of the total water use in an office building (excluding leaks). Residential water use is much higher per person than office water use, including both showers (approximately 20% of residential use – excluding cooling and heating) and washing (approximately 19% - excluding cooling and heating) (DeOreo et al 2015), so the proportion of water use allocated to cooling towers and “other” would be expected to be lower than that in office buildings. As such, at 39% the estimated proportion of “cooling tower and other” water use is higher than expected for a building with residential water use and taken with increases to water use is worth further investigation.

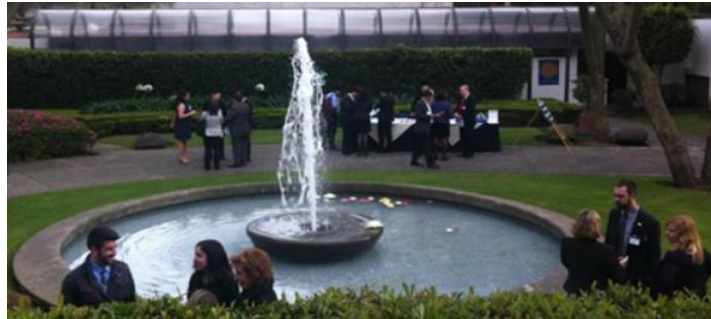
Figure 3 outdoor reception space / Fountain

La Casa is one of two UCOP sites with irrigated turf, but the only one with running fountains. An estimate of 19,558 sq ft of landscaping has been made using property plans. This area contains both trees and turf as well as two fountains.

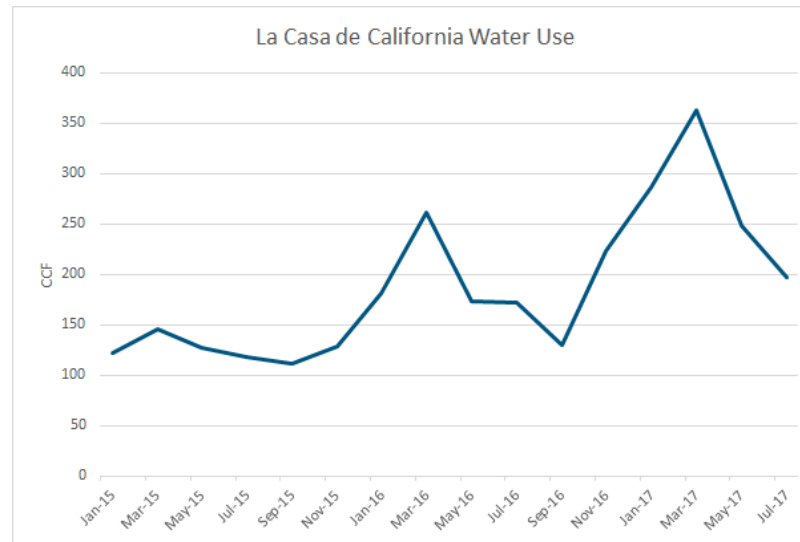
Graph 10 La Casa De California Water Use, data sourced from water bill data in Energy Cap

Graph 10 shows overall water use for La Casa between January 2015 and July 2017. The peaks in the graph correspond with the dry season in the city, which calls for higher water use to maintain landscaping. While there appears to be a large drop in water use for the July 2017 billing cycle, it should be taken into account that July falls in Mexico City's rainy season, and July 2017 water usage is significantly higher than July water usage for previous years, and has grown from year to year. The peak water usage has also been increasing each year as well despite there being larger average and total rainfall in 2017 than in previous years (Weather Underground, 2017b).

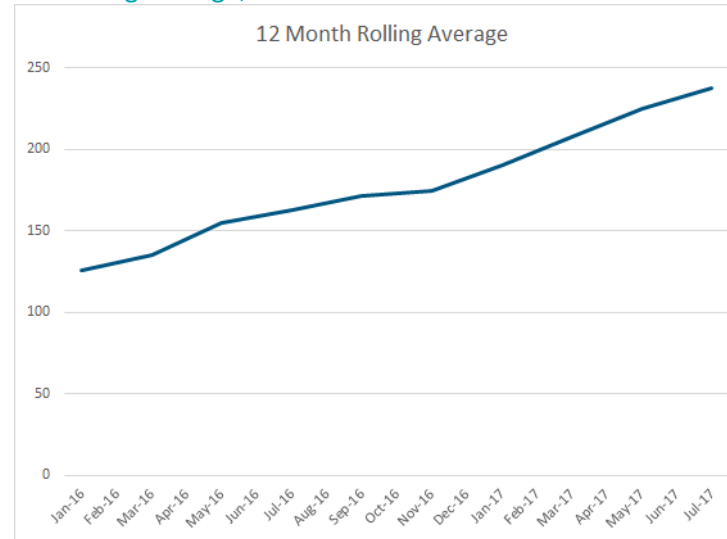
Graph 11: La Casa De California Water Use,  
12 month rolling average, data sourced from water bill data in Energy Cap

The twelve month rolling average graph shows an upward trend in water usage over the past year and a half. The upward trend could be a result of an undetected leak or higher use and maintenance of the facility. A logging meter would help detect where increases in water use are occurring and allow for a more targeted response to increase water efficiency at the site.

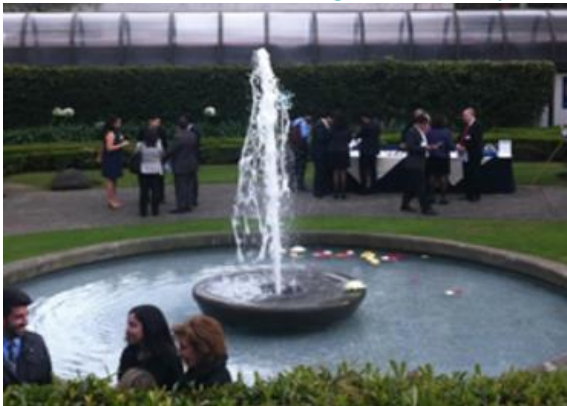
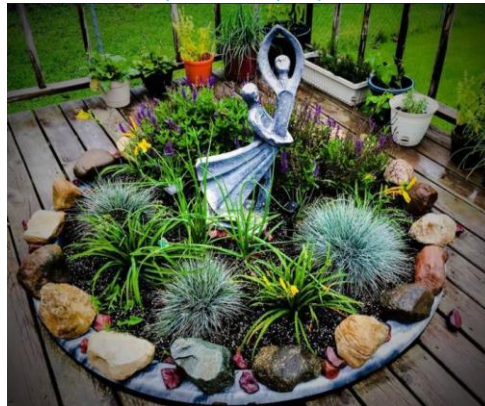
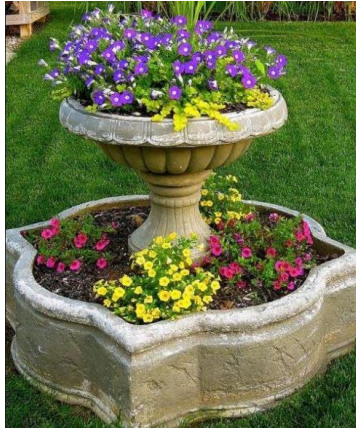
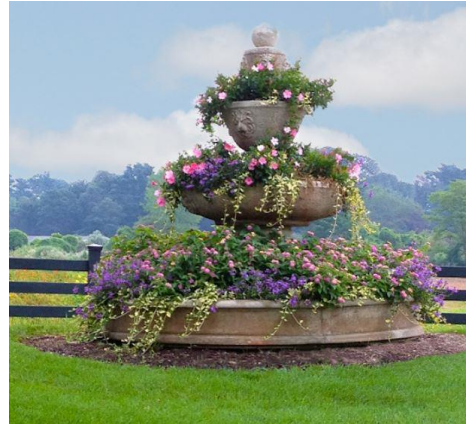
Figures 4-10, top left - existing fountain; examples of repurposed fountains

5. Consideration should be given to re-purposing the fountains at La Casa (see figures 4-10 for example).
6. Consideration should be given to sub- metering the three buildings not occupied by UCOP eventually moving them off an all in lease.

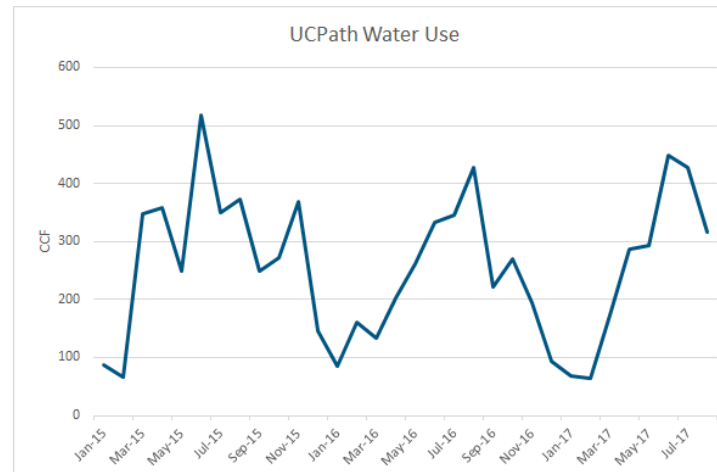
Graph 13: UCPath Water Use (potable and non-potable) (Data Source- Water Bills in EnergyCAP)

Graph 13 shows total water use by the UCPath center. The peaks in water use correspond with the hotter summer months, when the HVAC system is using more water to keep the building cool, and more water may be required to maintain landscaping.

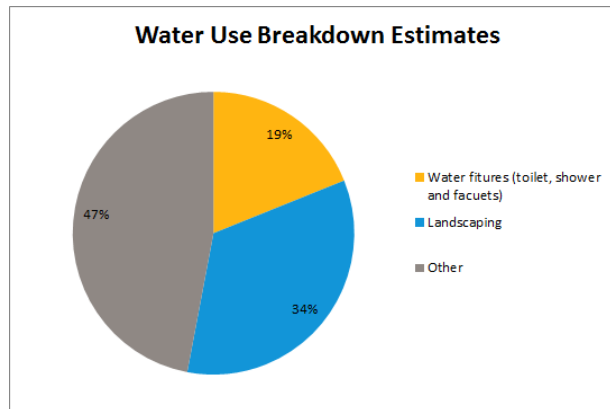
Graph 14: Breakdown of UCPATH Water Use

Analysis of UCPATH's water usage shows the largest proportion of water going to the 'Other' category and to landscaping. This could be likely due to a growing population not reflected in fixture use estimates

Table 14 shows the estimated total water use from fixtures at UCPATH to be 500 CCF per year, which accounts for approximately 20% of UCPATH's total water use. The EPA's Office Benchmarks state that 50% of a building's total water consumption is used by fixtures in the building (EPA, 2016). UCPATH's 20% is significantly lower than this figure which represents efficient fixtures and / or high usage for some other activities. Retrofitting the toilets that do not meet WaterSense standards would not result in significant water saving for the center and will not be recommended as an action due to the low water costs at Riverside, but may be considered.

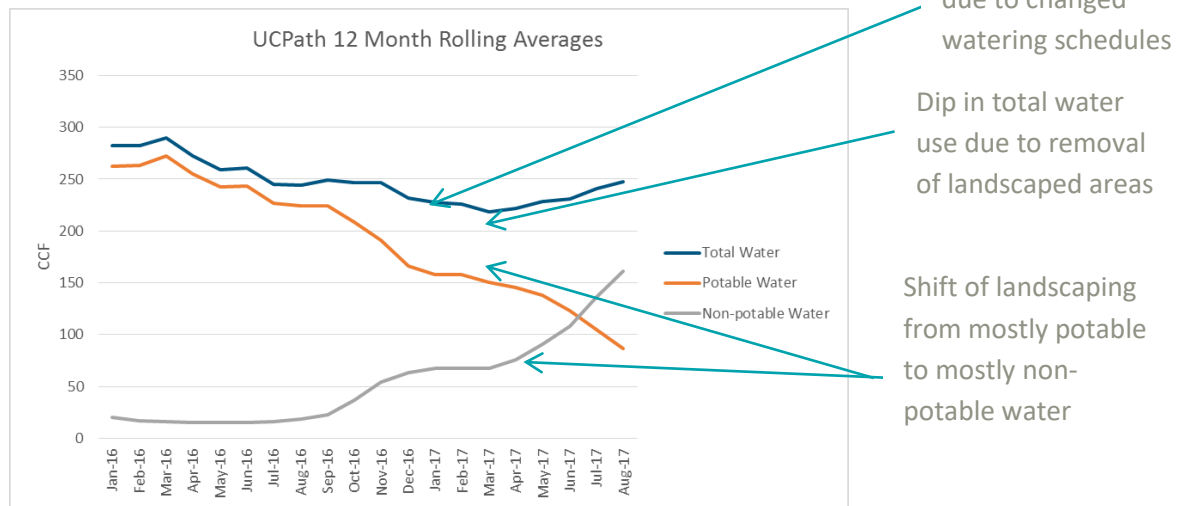
**Graph 15: 12 Month Rolling Average of UCPATH Water (Source-WMWD Water Bills in EnergyCAP)**

Overall, there appears to be a downward trend in gross and normalized water usage despite a growing staff. In addition, water use has shifted from predominantly potable to predominantly non potable. The impact of removing the landscaped islands and reduction of the number of

watering days and length of watering is evidenced in decline in use. Installing loggers can provide more information on how water is used at UCPATH and help staff target higher water use activities more effectively as well as identify leaks. The small and decreasing percentage of potable water use suggests that the bulk of the site's water is use for landscaping.
